Manhole Inspection Summary

Manhole # S2701_013MH

Insp Date: **2/25/08 1:50 PM**

Location Address: **1097 Slater Road**

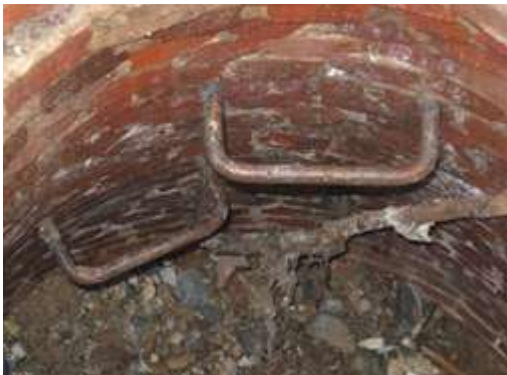
Steps

Count: **3** Missing: **0** ☐ Corroded

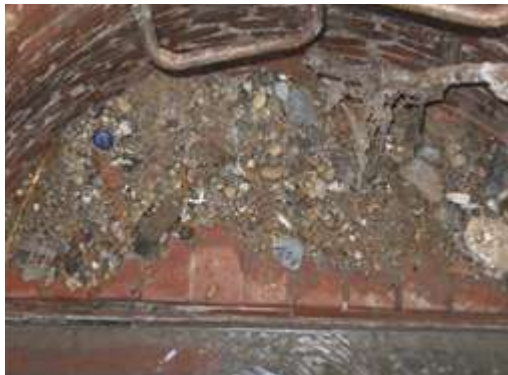
Defect 3

Condition: ☒ Sound ☐ Cracked ☐ Root Intrusion ☐ Deteriorated ☐ Leaks ☐ Debris

Bench

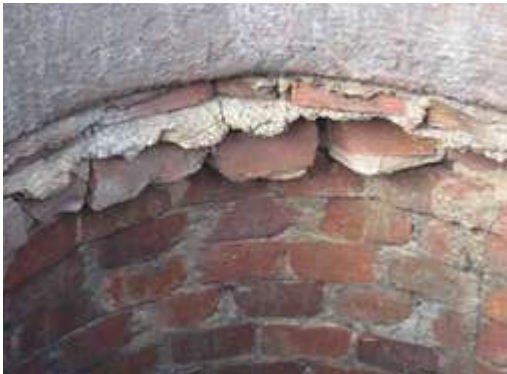
Defect 2

Condition: ☐ Sound ☐ Cracked ☐ Root Intrusion ☒ **Loose Brick** ☐ Deteriorated

Infiltration: ☐ None ☒ **Joint** ☐ Cracks ☒ **Mortar** ☐ Roots ☒ **Wall**

Chimney

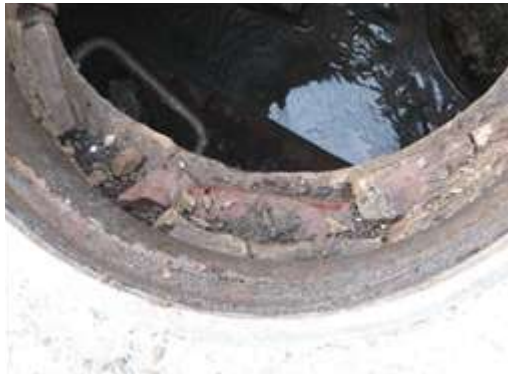
Defect 1

Offset: **4** (in.)

Frame offset

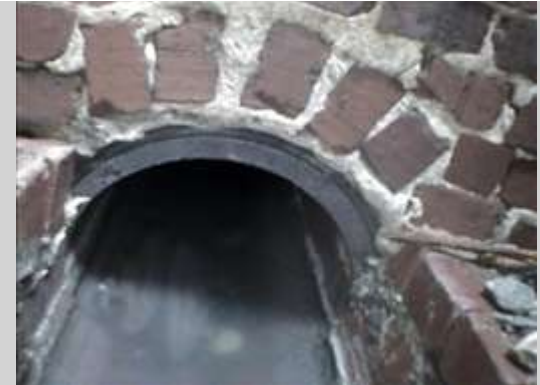
12 O'Clock Outflow

12 in. Circular Gravity Sewer
Pipe Out @ 12 O'Clock

Pipe Height: **14.4** (in.) Rod and Bar (Angled)
Pipe Material: **Clay** ☐ Pipe Lined
Invert Depth: **7.76** (ft.) Flow Characteristics: **Slow**
Deposits: ☒ None ☐ Mud ☐ Sludge ☐ Debris ☐ Grease
Silt Depth: (in.) Deposits Extent:
Infiltration: **None** Pipe Seal Cond: **Sound**

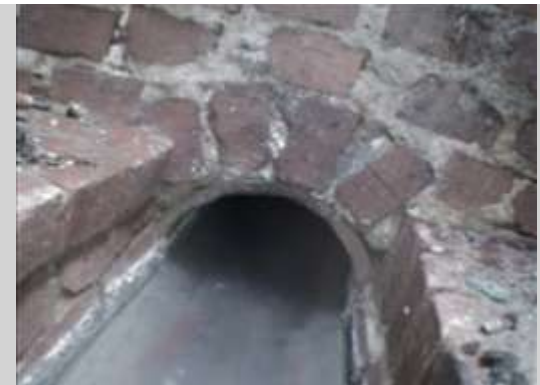
6 O'Clock Inflow

8 in. Circular Gravity Sewer
Pipe In @ 6 O'Clock

Pipe Height: **9.6** (in.) Rod and Bar (Angled)
Pipe Material: **Clay** ☐ Pipe Lined
Invert Depth: **7.74** (ft.) Flow Characteristics: **Slow**
Deposits: ☒ None ☐ Mud ☐ Sludge ☐ Debris ☐ Grease
Silt Depth: (in.) Deposits Extent:
Infiltration: **None** Pipe Seal Cond: **Sound**

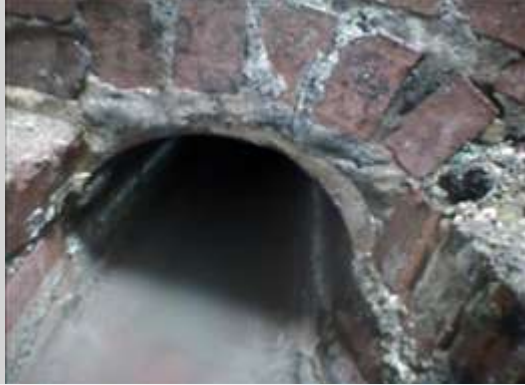
9 O'Clock Inflow

10 in. Circular Gravity Sewer
Pipe In @ 9 O'Clock

Infiltration: **None** Pipe Seal Cond: **Sound**
